**EVALUATION OF
MINE-WATER DISCHARGE IMPACTS IN
ECCLES CREEK AND MUD CREEK**

**CANYON FUEL COMPANY
Skyline Mine
Scofield, Utah**

December 2002

EARTHFAX ENGINEERING, INC.
Engineers/Scientists
Midvale, Utah

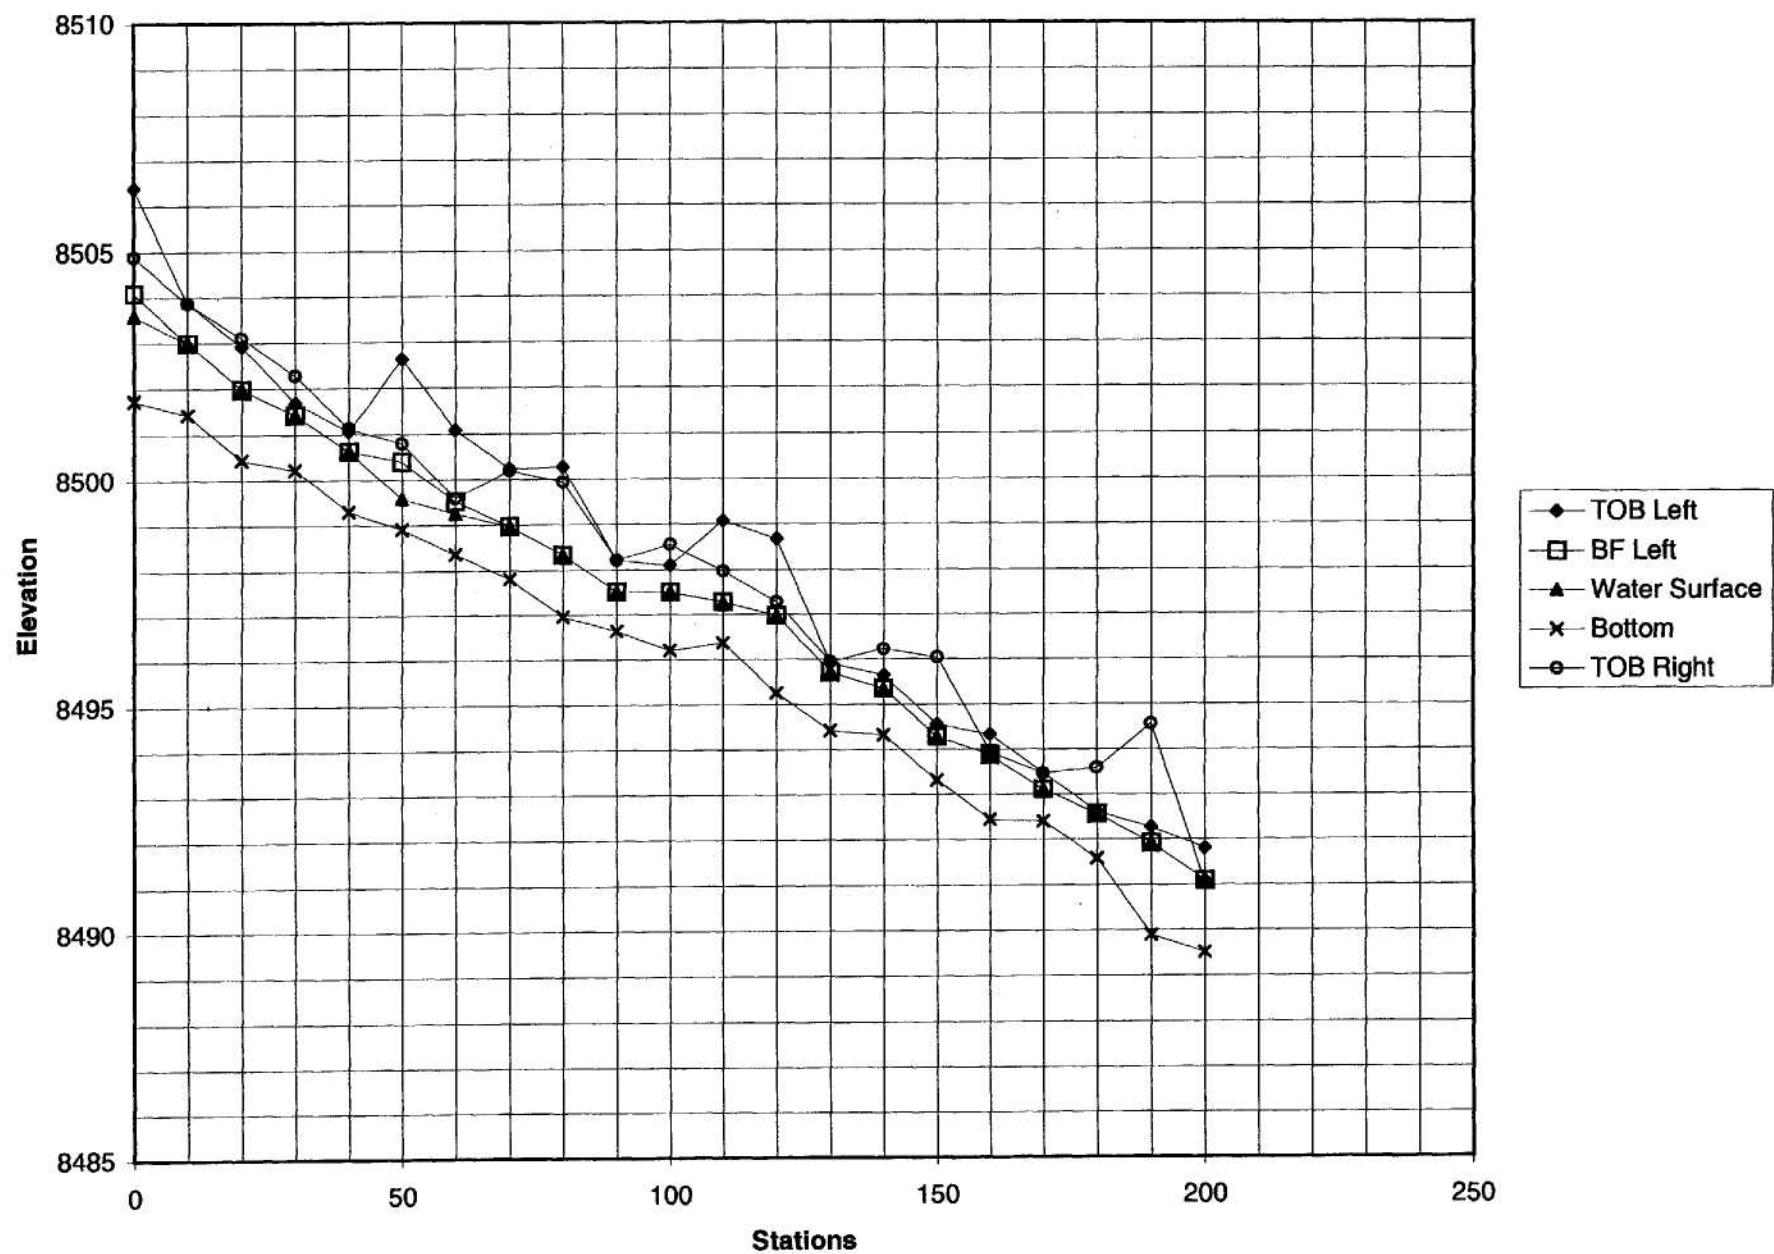
Profile EC-1

Profile:	EC-1	BenchMark Elev:		8499.127							
	BenchMark1:		7.32	BenchMark2:	1.55						
Station	TOB Left		BF Left		Water Surface		Bottom		TOB Right		
	Rod Reading	Elevation	Rod Reading	Elevation	Rod Reading	Elevation	Rod Reading	Elevation	Rod Reading	Elevation	
0	0.05	8506.397	2.35	8504.097	2.85	8503.597	4.7	8501.747	1.55	8504.897	
10	2.57	8503.877	3.45	8502.997	3.45	8502.997	5.01	8501.437	2.58	8503.867	
20	3.53	8502.917	4.47	8501.977	4.47	8501.977	6.01	8500.437	3.34	8503.107	
30	4.76	8501.687	5.02	8501.427	5.02	8501.427	6.22	8500.227	4.17	8502.277	
40	5.38	8501.067	5.82	8500.627	5.82	8500.627	7.15	8499.297	5.32	8501.127	
50	3.82	8502.627	6.05	8500.397	6.87	8499.577	7.54	8498.907	5.65	8500.797	
60	5.36	8501.087	6.93	8499.517	7.2	8499.247	8.09	8498.357	6.86	8499.587	
70	6.21	8500.237	7.48	8498.967	7.48	8498.967	8.64	8497.807	6.25	8500.197	
80	6.18	8500.267	8.11	8498.337	8.11	8498.337	9.49	8496.957	6.51	8499.937

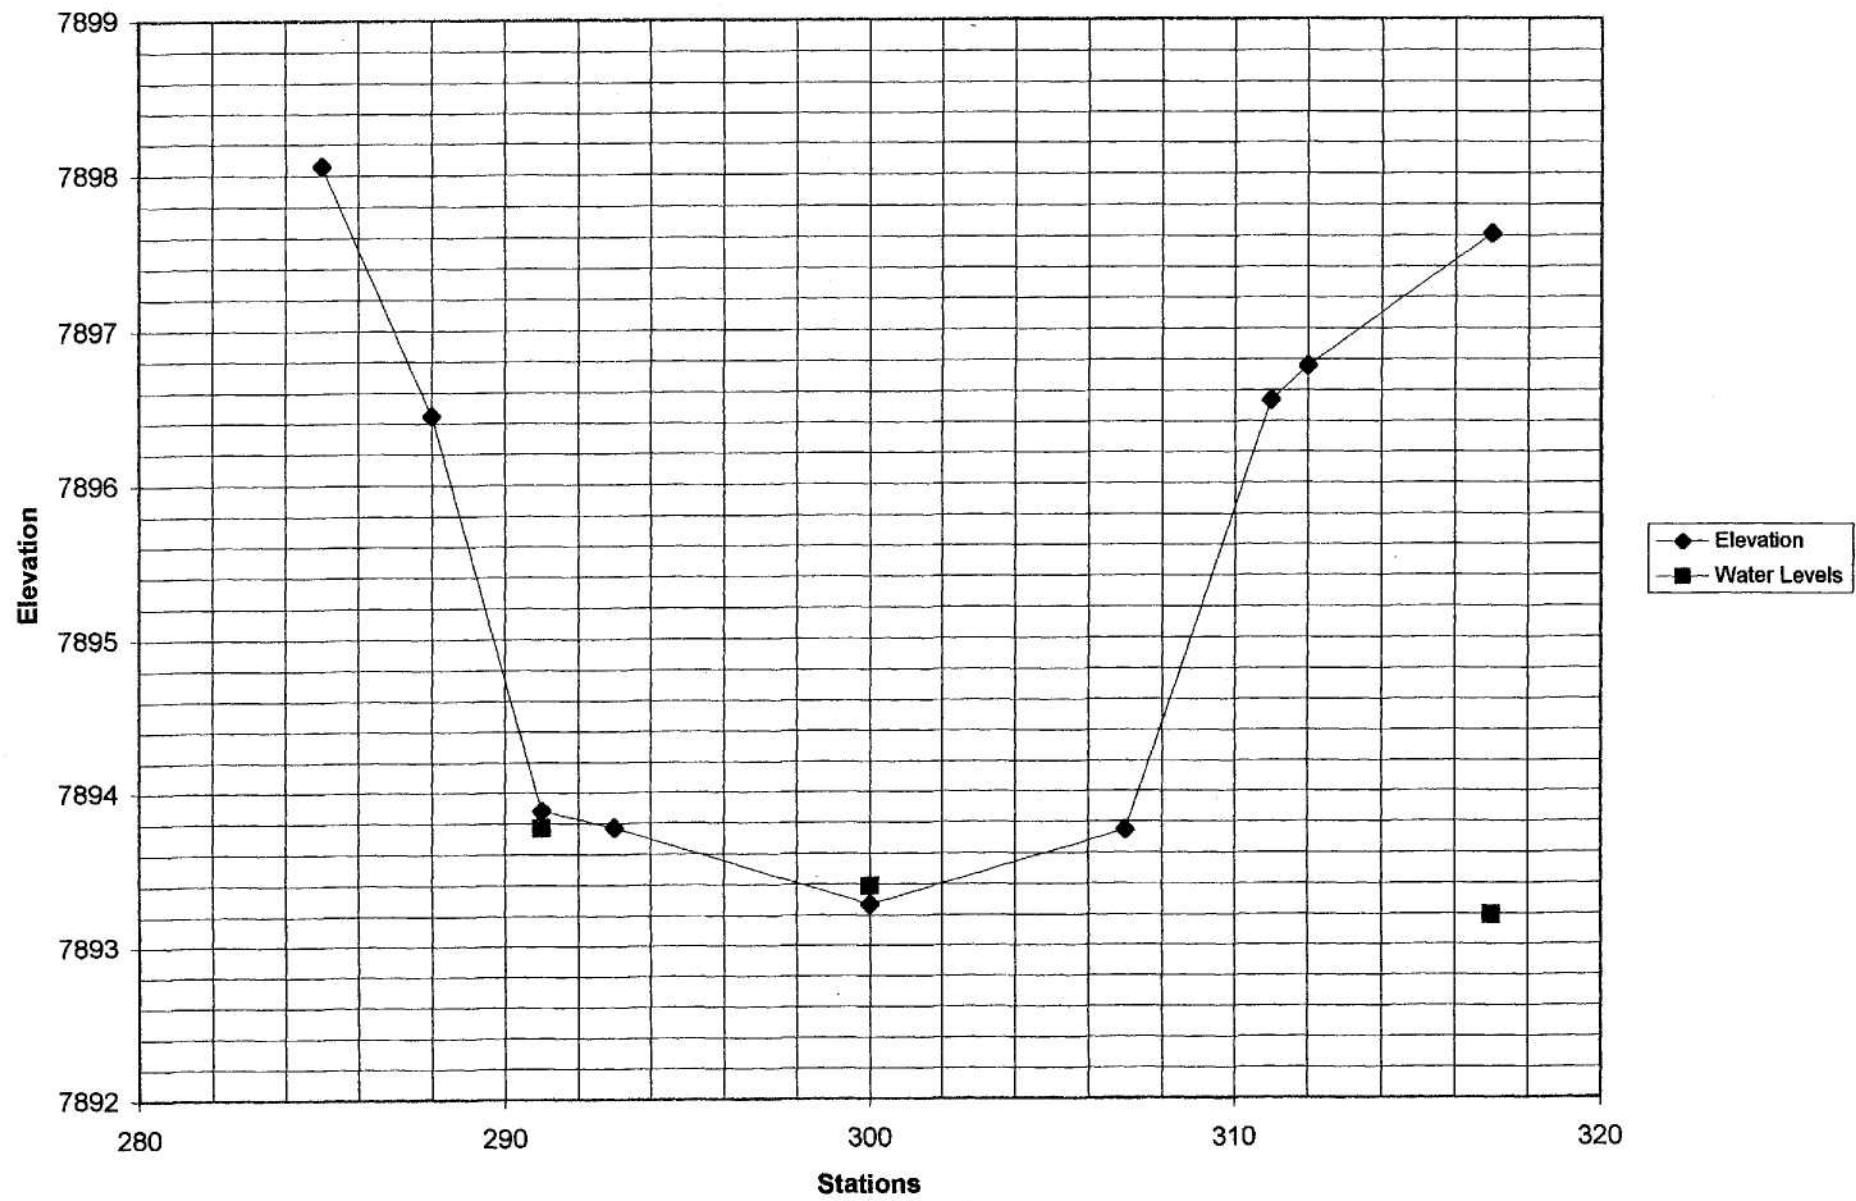
Cross-Section MC-1

Cross Section: MC-1 Elev: 7898.53
BenchMark1: 0.74

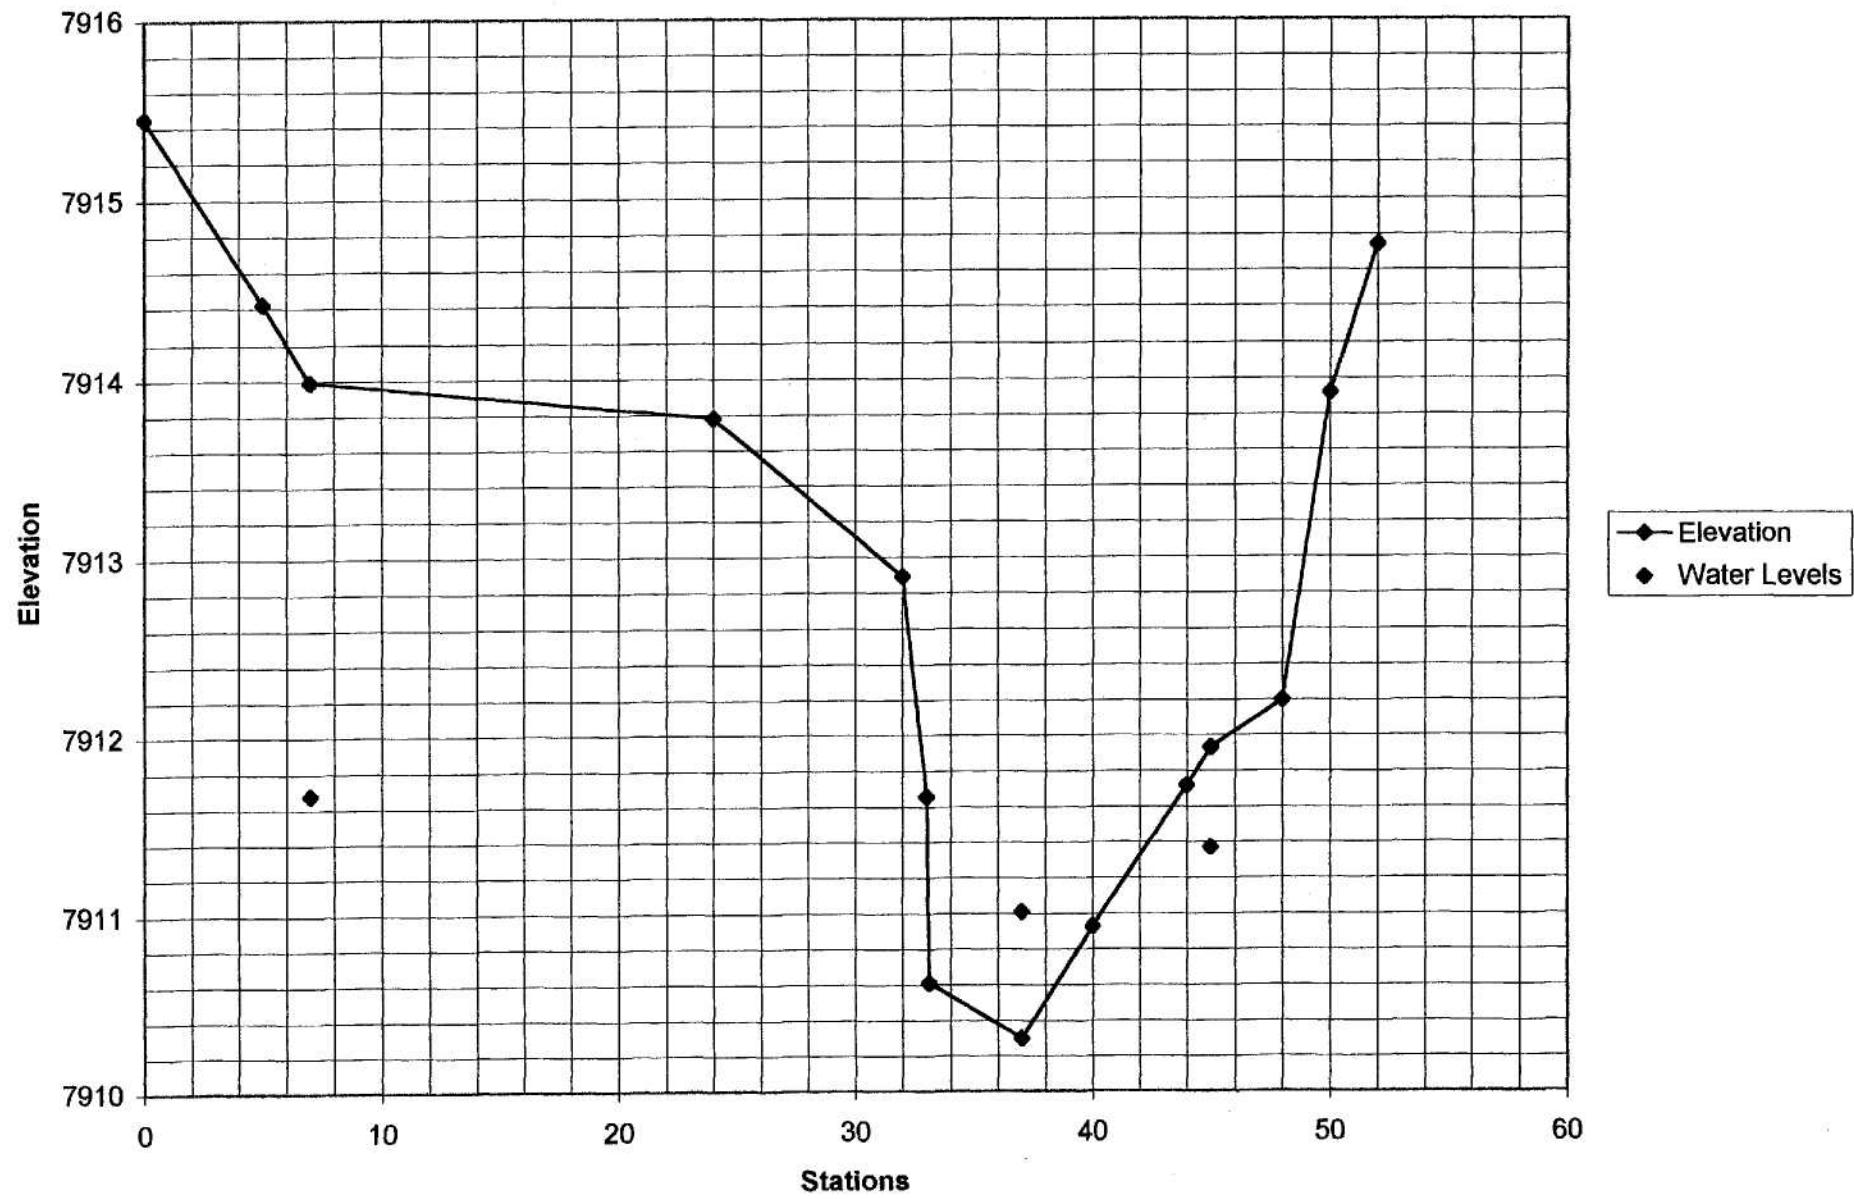
Cross-Section MC-5

Cross Section: MC-5 Elev.: 7915.351

elevations. In the upper reaches of Mud Creek (i.e., cross-section locations MC-5, MC-1 and MC-2, see Attachment E), the piezometer water levels show different conditions at the reference sites. At MC-5, the piezometer water levels are higher than the water in the stream indicating that the groundwater flow is toward the creek. At MC-1 and MC-2, the piezometer water levels are different on both sides of the channel indicating that the groundwater is flowing across the canyon from areas of high water levels on the east of the channel to areas of lower water levels on the west of channel. The elevated groundwater on the east side of the channel may be influenced by the water loss from the stream channel at the mouth of Eccles Canyon or it may indicate recharge to the valley from the east..

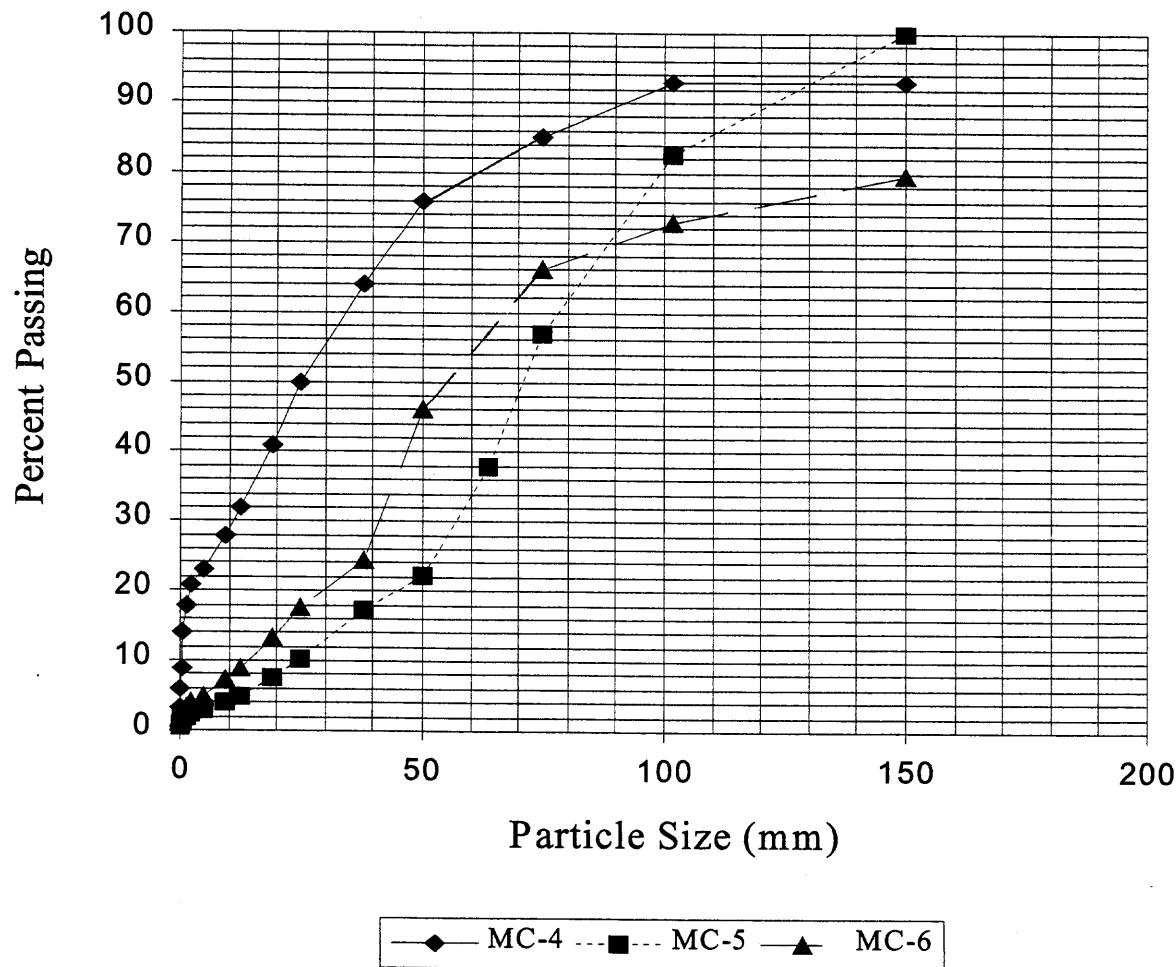
Mud Creek Bed Gradations

<u>MC-4</u>	<u>MC-5</u>	<u>MC-6</u>
$D_{10} = 0.32$	$D_{10} = 24$	$D_{10} = 14$
$D_{30} = 11$	$D_{30} = 57$	$D_{30} = 41$
$D_{60} = 34$	$D_{60} = 78$	$D_{60} = 67$
$C_v = D_{60}/D_{10} = 106 > 4$	$C_v = 3.2 < 4 \Rightarrow GP$	$C_v = 4.8 > 4 \quad \left. \begin{array}{l} C_z = 1.8 \\ \end{array} \right\} \Rightarrow GW$
$C_z = \frac{D_{30}^2}{D_{10}D_{60}} = 11 > 3 \Rightarrow GP$

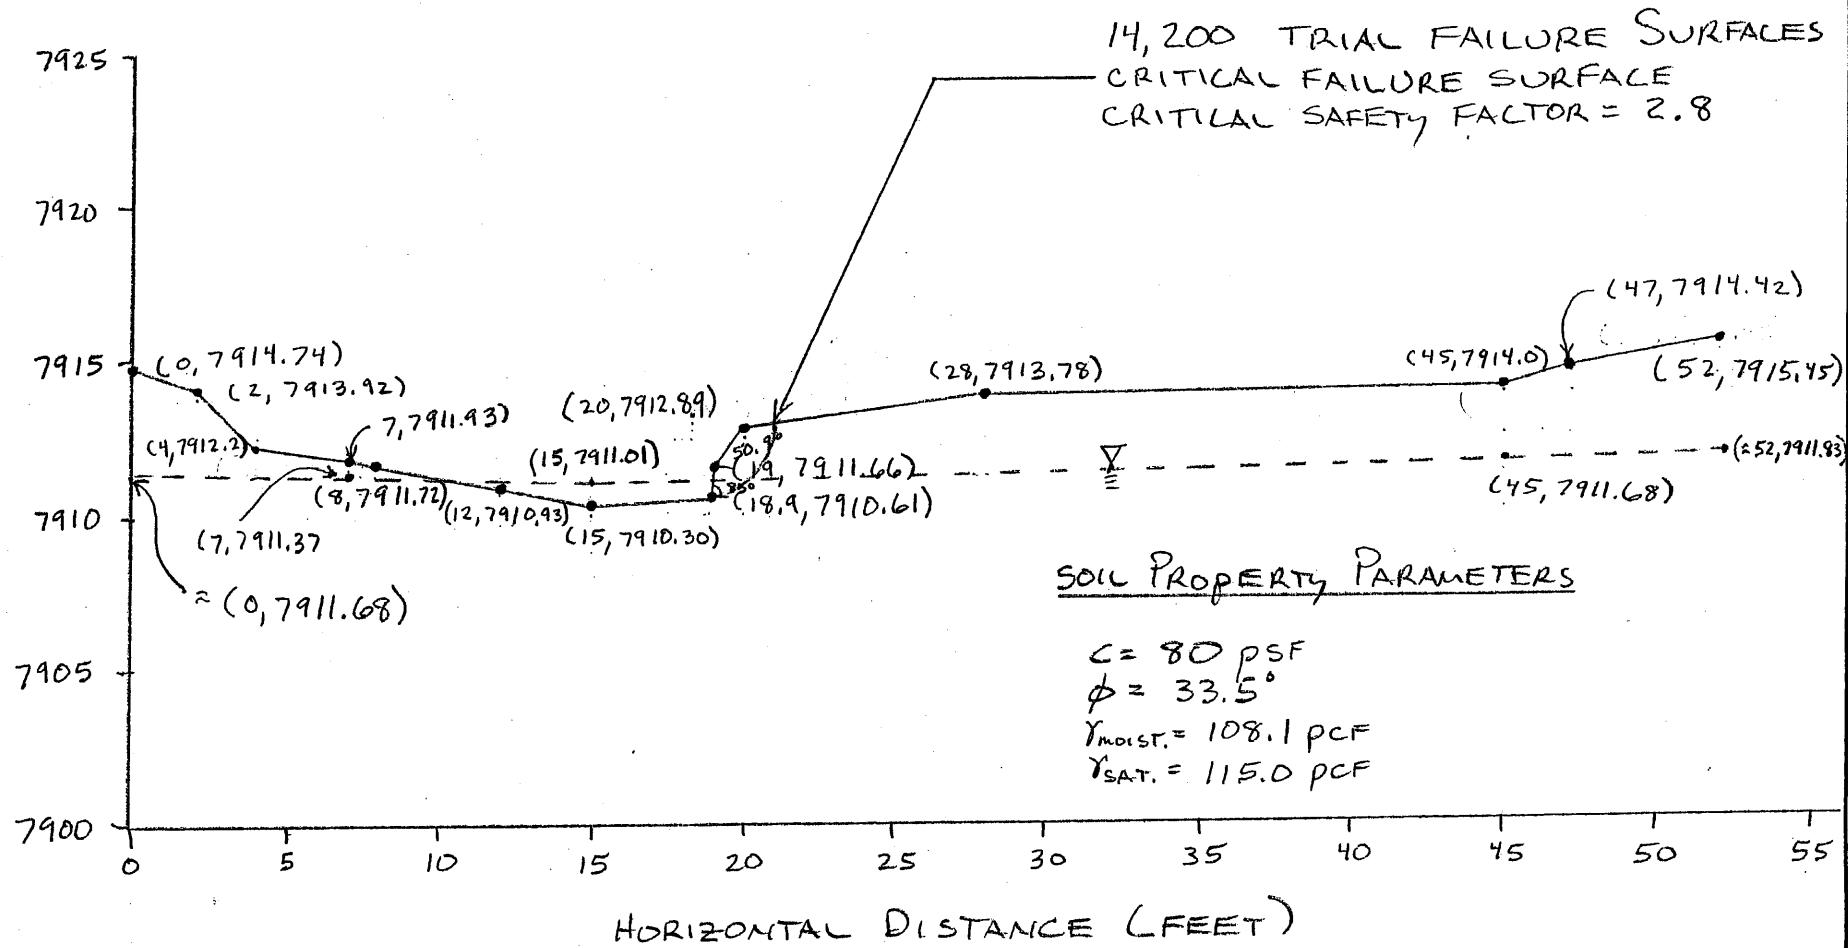
CANYON FUEL COMPANY
SKYLINE MINE DISCHARGE STUDY
SECTION MC - 5

Slope stability analyses were performed using the computer program GEOSLOPE (Version 5.0). GEOSLOPE utilizes the limit equilibrium procedure of slices (Simplified Bishop's method) to determine the safety factor of potential failure surfaces for circular shapes.
